Use Attainability Analysis

WBID 1284 Middle Fork Tebo Creek

Submitted by
Tetra Tech, Inc

To
Missouri Department of Natural Resources
Water Protection Program

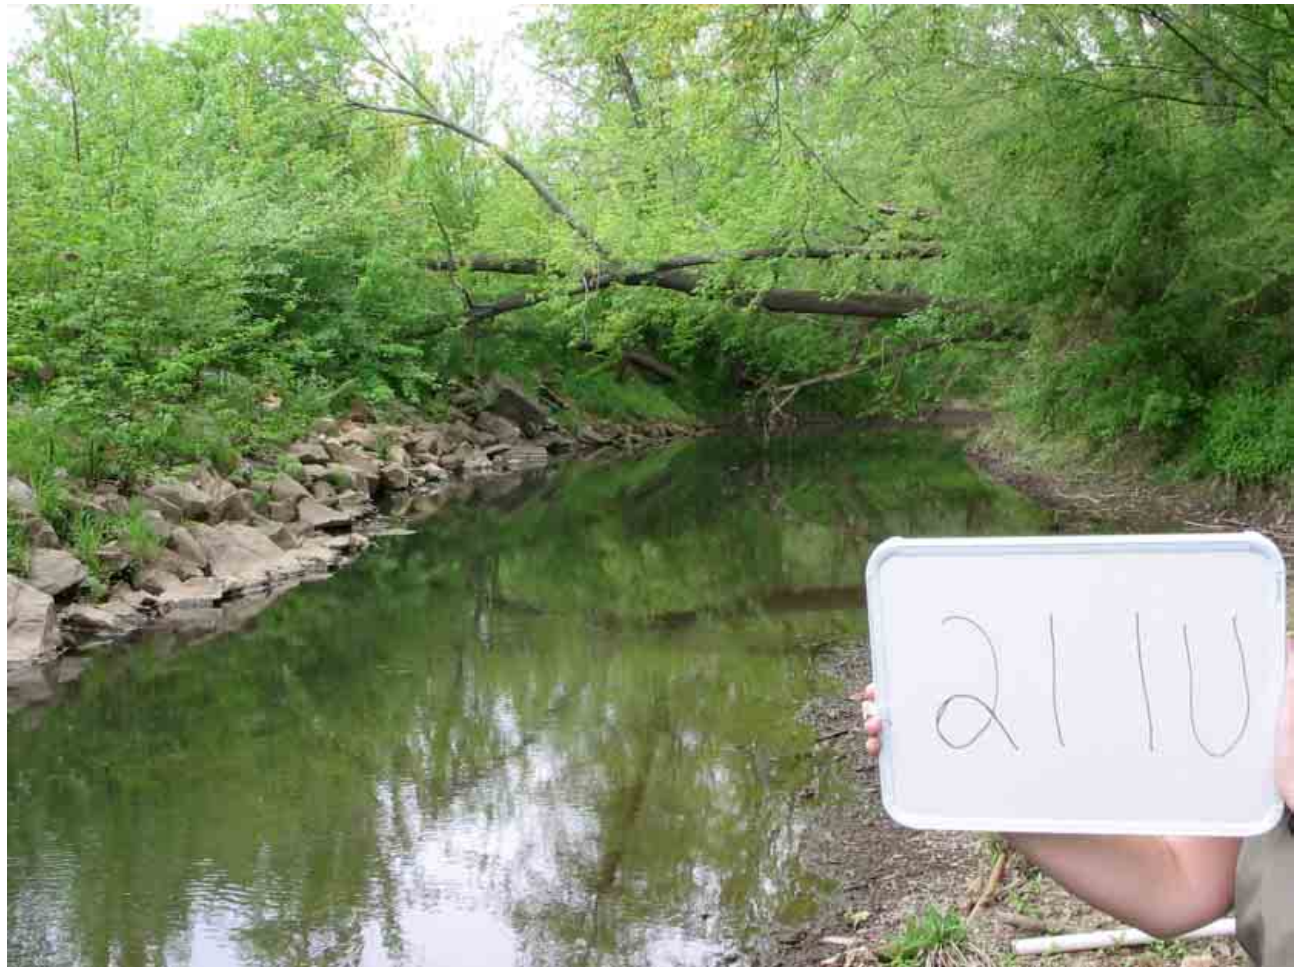
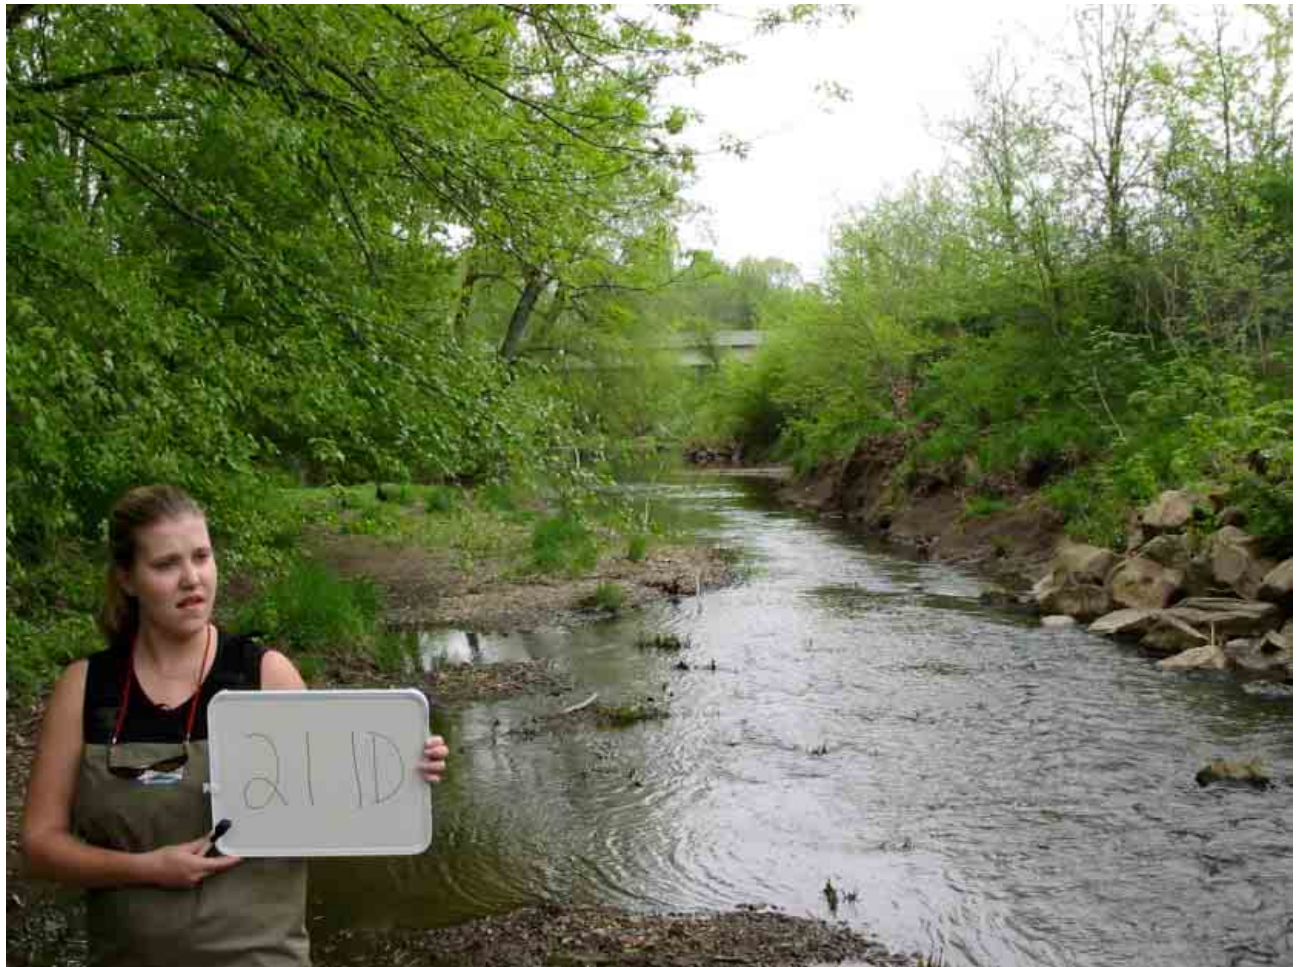
Missouri WBID #: 211 / Alternate	Site Location Description: Upstream of Rt 52 overpass	
Site GPS Coordinates: N 38.46939 W 093.61734		
Date & Time: 4-20-2005 1231	Facility Name: Middle Fk Tebo CR	
Personnel: CB, ELY	Permit Number:	
Current Weather Conditions: Overcast 75°	Weather Conditions for Past 7 days: Clear warm	
Photo Ids: Upstream: T736A 012	Downstream: T735A 011	Other:

Sewage treatment plant on Right bank of reach

Upstream View Physical Dimensions: in m: 0.25, .52, .86, 1.0, .70

Downstream View Physical Dimensions: in m: .08, .18, .25, .22, .08

<input type="checkbox"/> Riffle	Width (ft):	Length (ft):	Avg. Depth (ft):	Max. Depth (ft):
<input checked="" type="checkbox"/> Run	Width (ft): <u>3.1m</u>	Length (ft): <u>20m</u>	Avg. Depth (ft): <u>0.162m</u>	Max. Depth (ft): <u>0.25m</u>
<input type="checkbox"/> Pool	Width (ft):	Length (ft):	Avg. Depth (ft):	Max. Depth (ft):
<input checked="" type="checkbox"/> Flow Present?	<input checked="" type="checkbox"/> Yes <input type="checkbox"/> No	Estimated (ft ³ /sec): <u>3m / 3.6s = 0.83 m/s</u>

<u>10</u> % Cobble	<u>50</u> % Gravel	<u>0</u> % Sand	<u>20</u> % Silt	<u>20</u> % Mud/Clay	<u>0</u> % Bedrock
--------------------	--------------------	-----------------	------------------	----------------------	--------------------

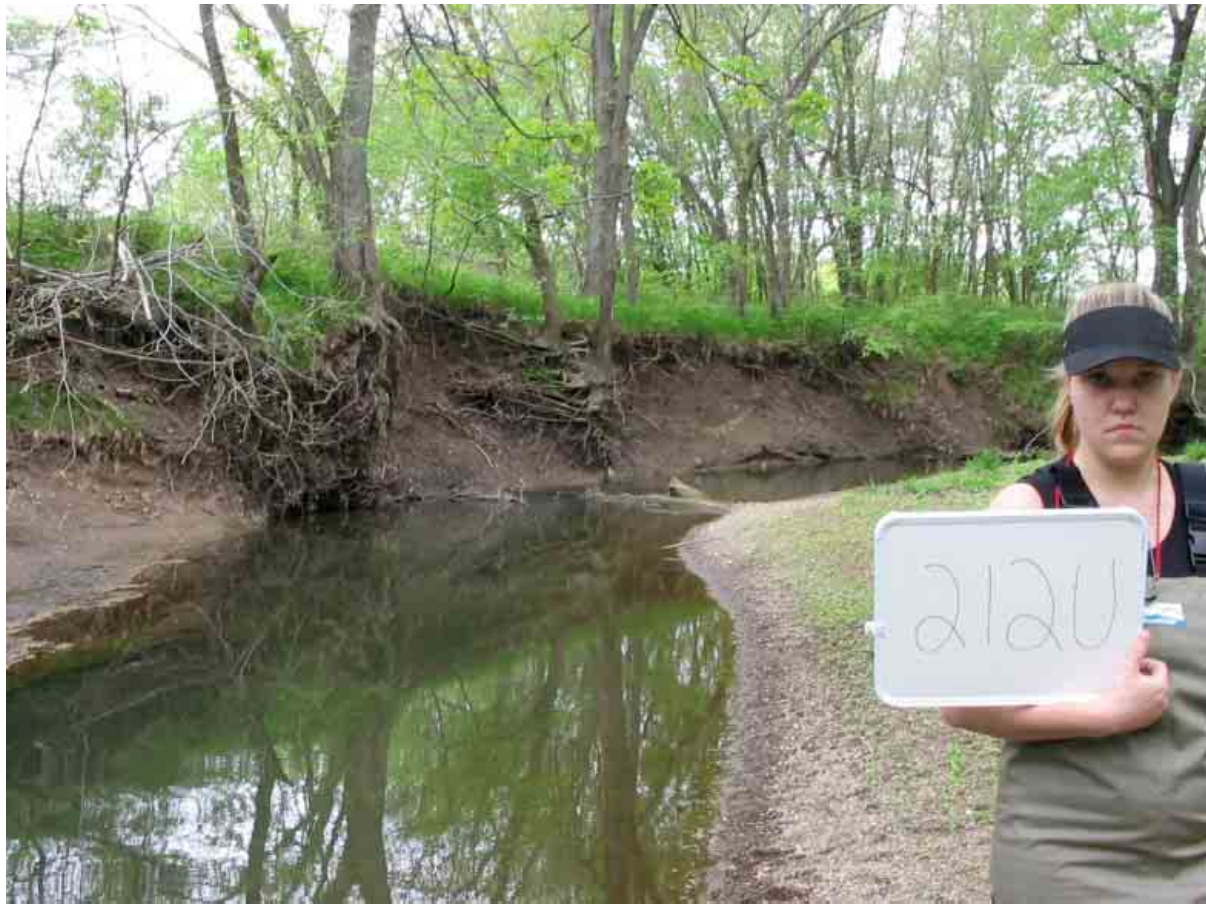
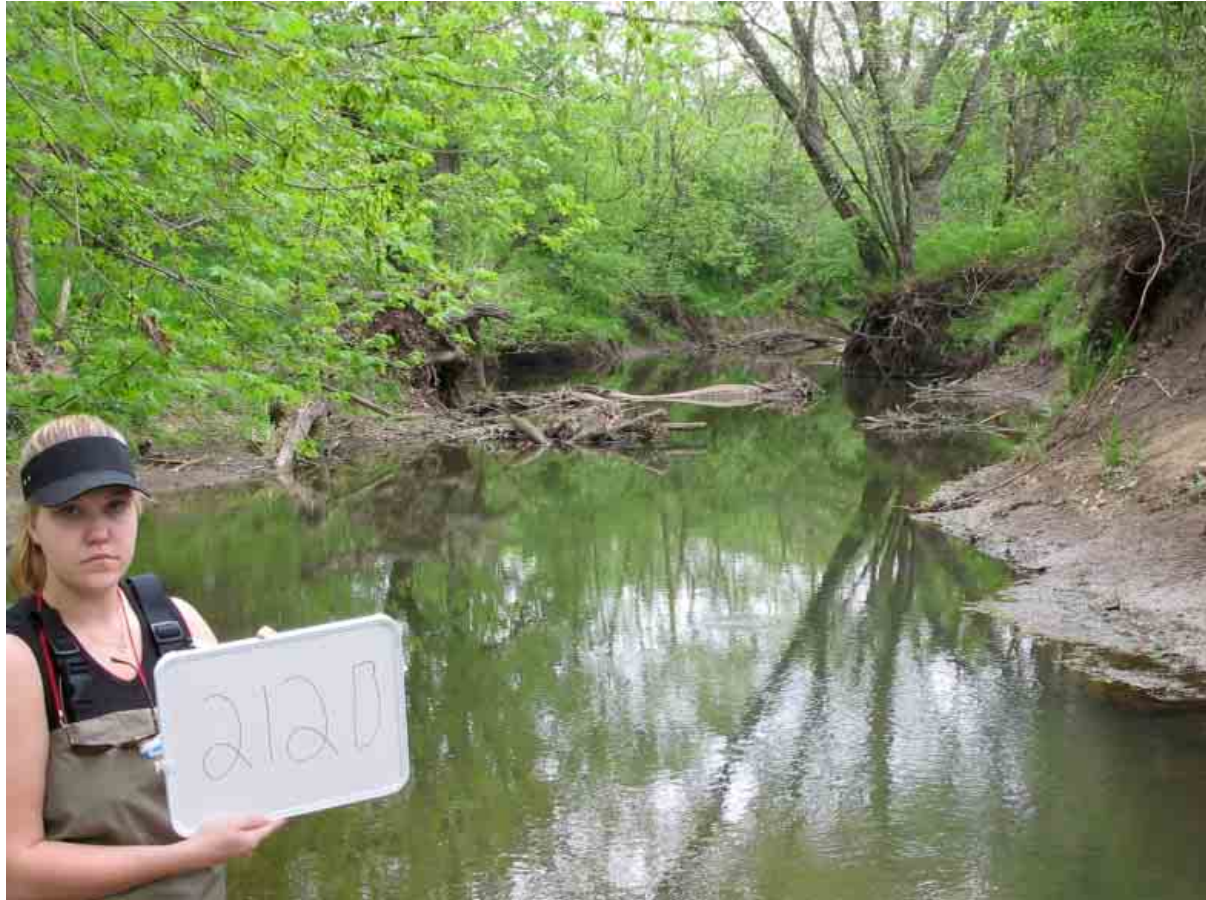
Missouri WBID #: 212	Site Location Description: downstream 500m Rt 50 overpass	
Site GPS Coordinates: N 38.46761 W 093.61589		
Date & Time: 4-20-05 11:35	Facility Name: Middle Fk Tebo CR	
Personnel: Chad Barbour E. Lee Yarbrough	Permit Number:	
Current Weather Conditions: Overcast 75	Weather Conditions for Past 7 days: Clear warm	
Photo Ids: Upstream: T733A 009	Downstream: T734A 010	Other:

Upstream View Physical Dimensions: in m: .09, .34, .45, .44, .26

<input type="checkbox"/> Riffle	Width (ft):	Length (ft):	Avg. Depth (ft):	Max. Depth (ft):
<input checked="" type="checkbox"/> Run	Width (ft): <u>5.8 m</u>	Length (ft): <u>20 m</u>	Avg. Depth (ft): <u>0.316 m</u>	Max. Depth (ft): <u>0.45 m</u>
<input type="checkbox"/> Pool	Width (ft):	Length (ft):	Avg. Depth (ft):	Max. Depth (ft):
<input checked="" type="checkbox"/> Flow	Present?	<input checked="" type="checkbox"/> Yes <input type="checkbox"/> No	Estimated (ft ³ /sec): <u>3 m / 10.6 s</u> = <u>0.30 m/s</u>

Downstream View Physical Dimensions: in m: 0.1, .44, .75, .88, .58

<input type="checkbox"/> Riffle	Width (ft):	Length (ft):	Avg. Depth (ft):	Max. Depth (ft):
<input type="checkbox"/> Run	Width (ft):	Length (ft):	Avg. Depth (ft):	Max. Depth (ft):
<input checked="" type="checkbox"/> Pool	Width (ft): <u>7.2 m</u>	Length (ft): <u>20 ft</u>	Avg. Depth (ft): <u>0.55 m</u>	Max. Depth (ft): <u>0.75 m</u>
<input checked="" type="checkbox"/> Flow	Present?	<input checked="" type="checkbox"/> Yes <input type="checkbox"/> No	Estimated (ft ³ /sec): <u>3 m / 17 s</u> = <u>0.18 m/s</u>

<u>5</u> % Cobble	<u>40</u> % Gravel	<u>0</u> % Sand	<u>0</u> % Silt	<u>55</u> % Mud/Clay	<u>0</u> % Bedrock
-------------------	--------------------	-----------------	-----------------	----------------------	--------------------

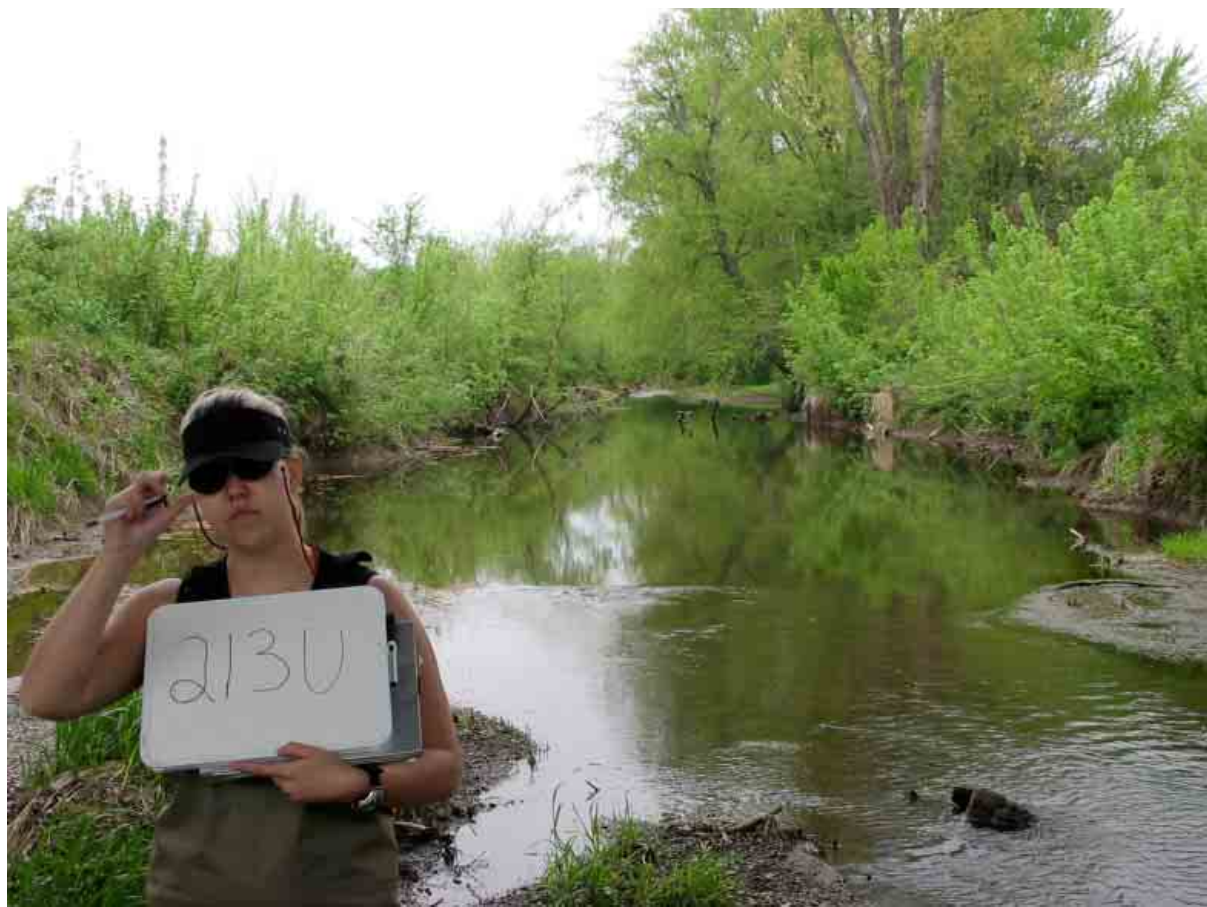
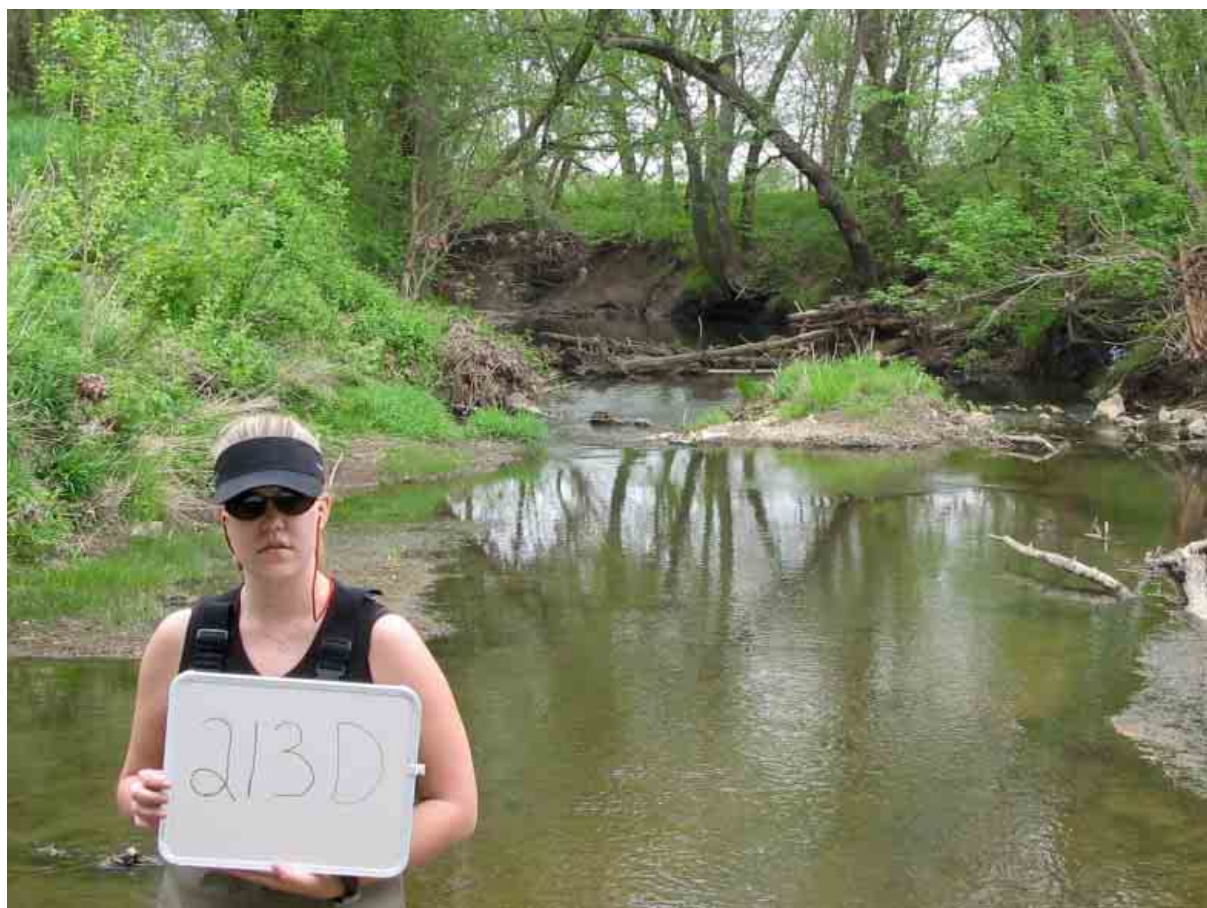
Missouri WBID #: 213	Site Location Description: Overpass off of 52
Site GPS Coordinates: N38.46822 W 095.61671	
Date & Time: 11-20-05 1100	Facility Name: Middle Flk Tebo CR
Personnel: Chad Barbour Lee Yarbrough	Permit Number:
Current Weather Conditions: Overcast 74°	Weather Conditions for Past 7 days: Clear, warm
Photo Ids: Upstream: T731A 007	Downstream: T732A 008 Other:

Treatment plant on upstream portion of Reach

Upstream View Physical Dimensions: in m: .18, .22, .20, .30, .40, .15

Downstream View Physical Dimensions: .15, .25, .25, .29, .16

<u>0</u> % Cobble	<u>30</u> % Gravel	<u>5</u> % Sand	<u>30</u> % Silt	<u>35</u> % Mud/Clay	% Bedrock
-------------------	--------------------	-----------------	------------------	----------------------	-----------

Aquatic plants & algae

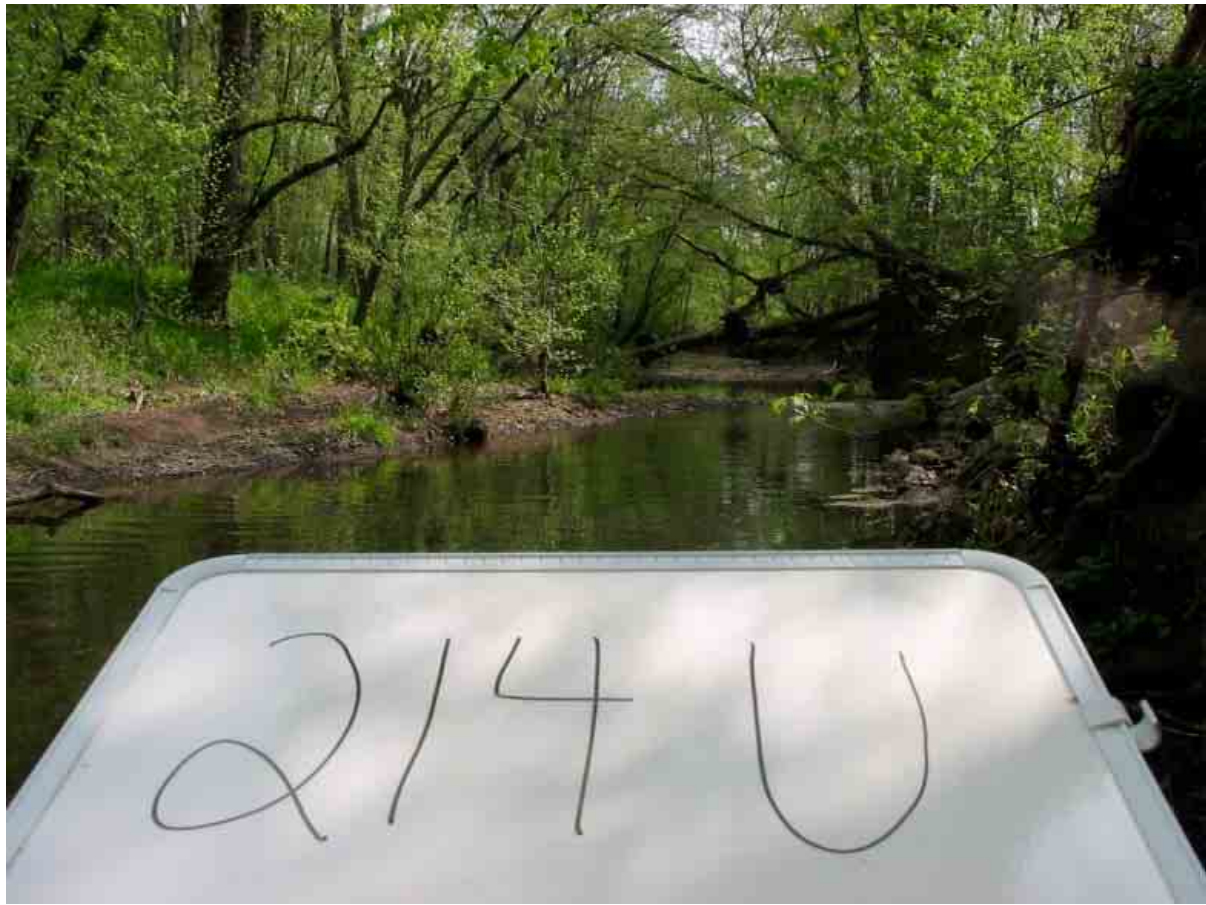
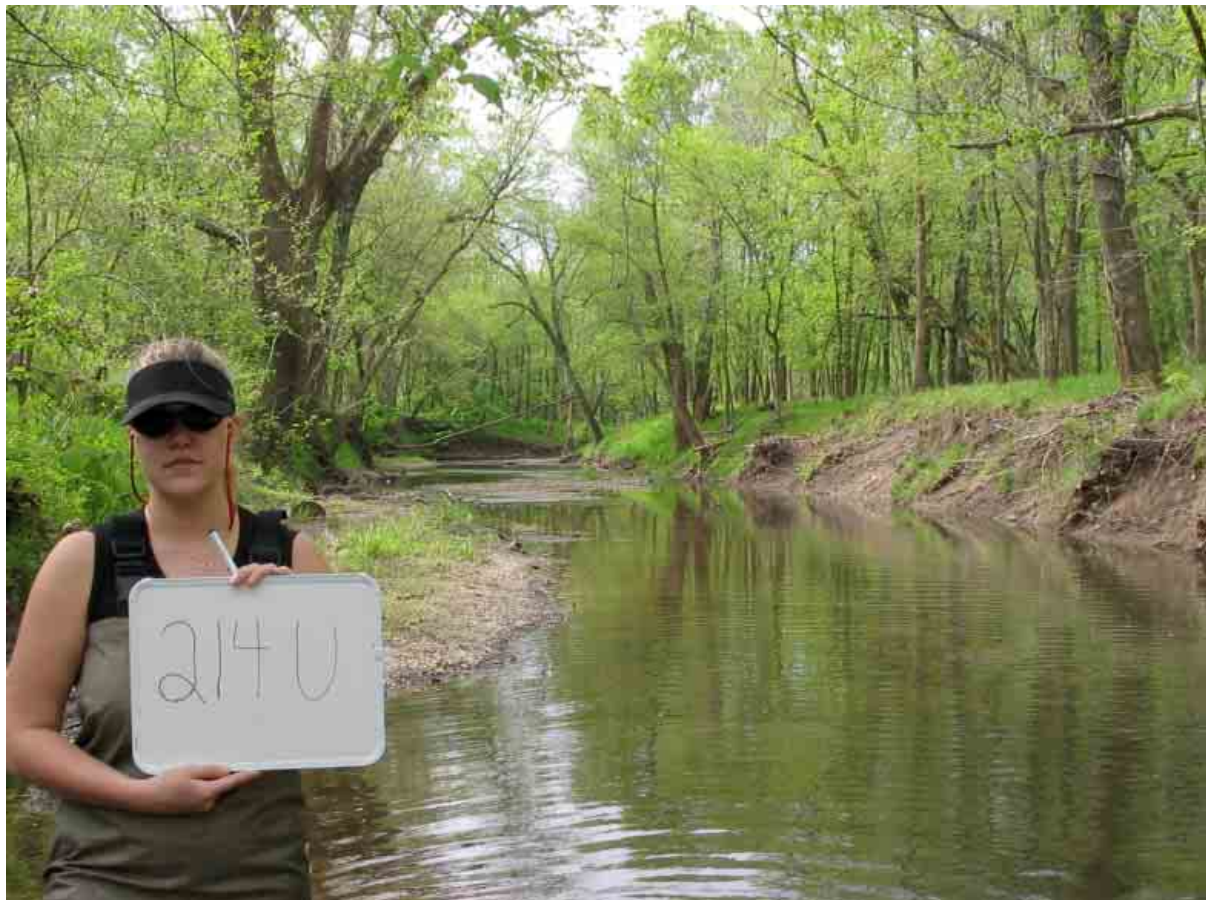
Missouri WBID #: 214	Site Location Description: Overpass off of NE950		
Site GPS Coordinates: N 38 49346 W 093 41063	Date & Time: 4-20-05 1015		
Date & Time: 4-20-05 1015	Facility Name: Butter WWTP middle Fk Tebo Cr		
Personnel: Chad Barbour Lee Yarbrough	Permit Number:		
Current Weather Conditions: Clear, 73°	Weather Conditions for Past 7 days: Clear, Warm		
Photo Ids: Upstream: 1729A ⁰⁰⁵	Downstream: 1730A ⁰⁰⁶	Other:

Describe: (include number of individuals recreating, frequency of use, photo-documentation of evidence of recreational uses, etc.)
 There is a large pool @ the x site approx depth 3.5m. (Extra data from area just within reach)

Upstream View Physical Dimensions: in m: 0.1, 0.27, 0.34, 0.45, 0.18

Downstream View Physical Dimensions: m: 0.09, 0.28, 0.52, 0.63, 0.25

<u>0</u> % Cobble	<u>65</u> % Gravel	<u>20</u> % Sand	<u>0</u> % Silt	<u>15</u> % Mud/Clay	<u>0</u> % Bedrock
-------------------	--------------------	------------------	-----------------	----------------------	--------------------

<u>Filamentous algae throughout.</u>

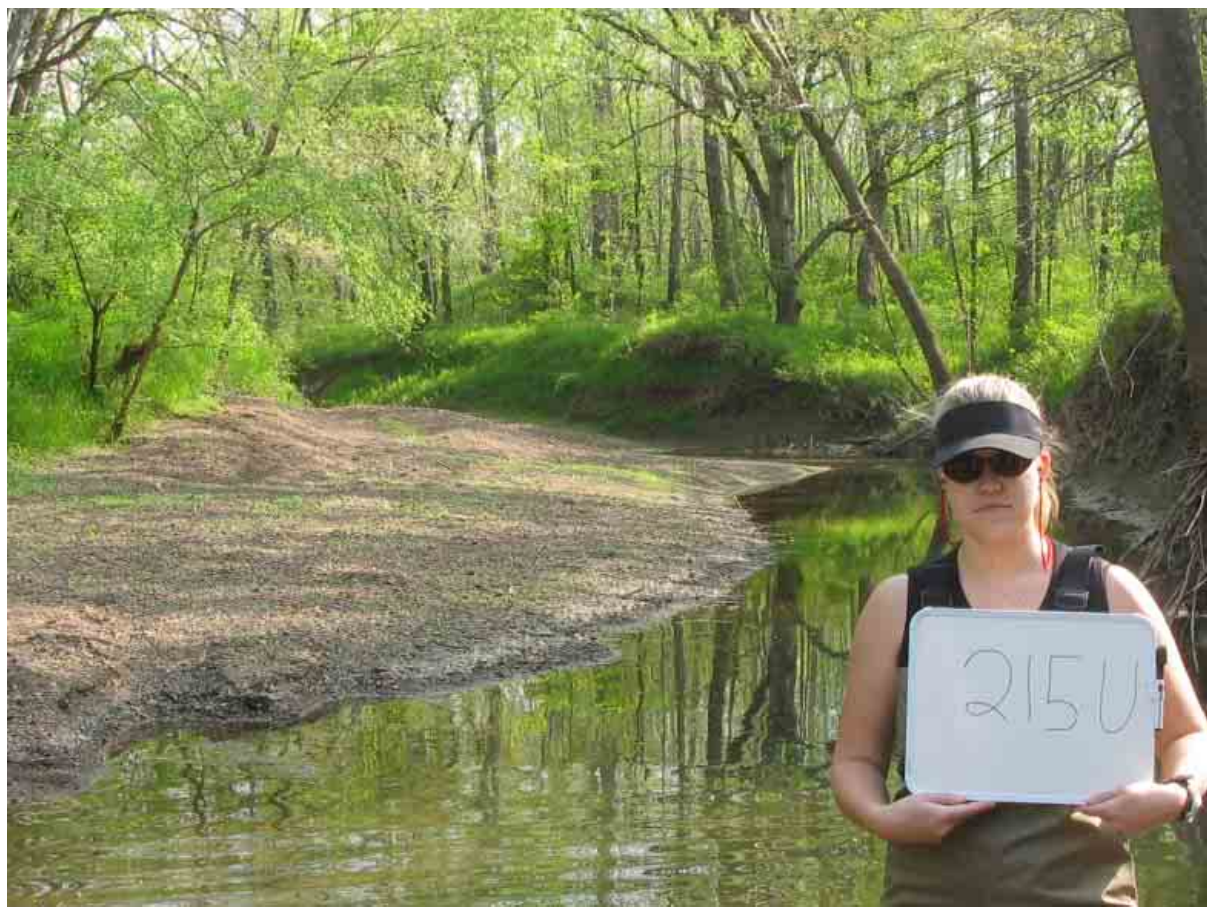
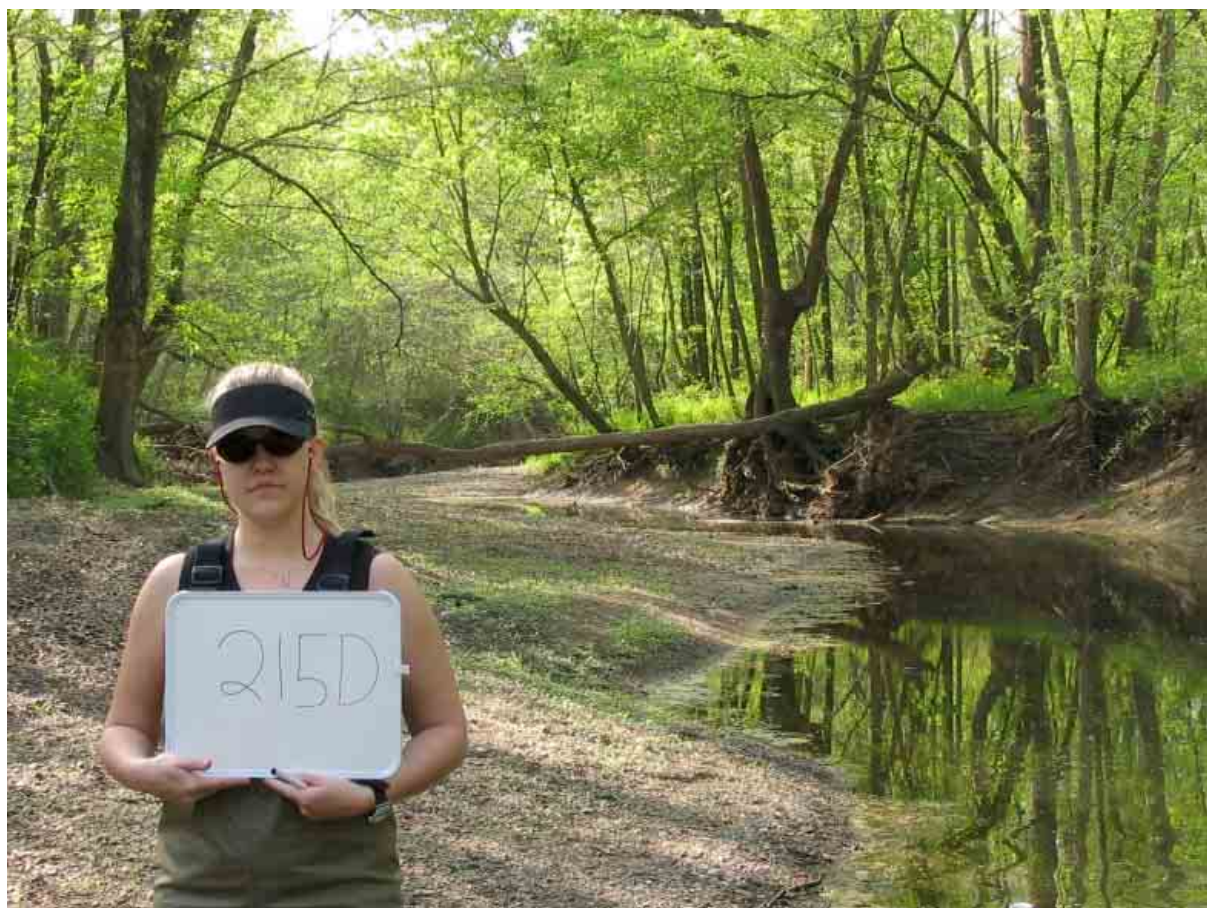
Missouri WBID #: 215	Site Location Description: Overpass off of CR NE 1130		
Site GPS Coordinates: N38.51865° W093.6116			
Date & Time: 4-20-05 933	Facility Name: Butler WWTP Middle Flk Tebock		
Personnel: Chad Barbour Lee Yarbrough	Permit Number: 8		
Current Weather Conditions: Clear 75°F	Weather Conditions for Past 7 days: Clear, Warm		
Photo Ids: Upstream: 1727A 003	Downstream: 1728A 004	Other:

- clear water
- milky bottom
- oil shine
- algae
- good riparian zone
- steep banks where there is no gravel bar
- Stream banks appear stable
- ~75% gravel 25% mud/silt (some woody debris)
- measured depth about every 2 feet across transect
- used a stick floating on surface to measure flow along certain distance
- water is at baseflow - maybe a little lower than normal or what it has been.

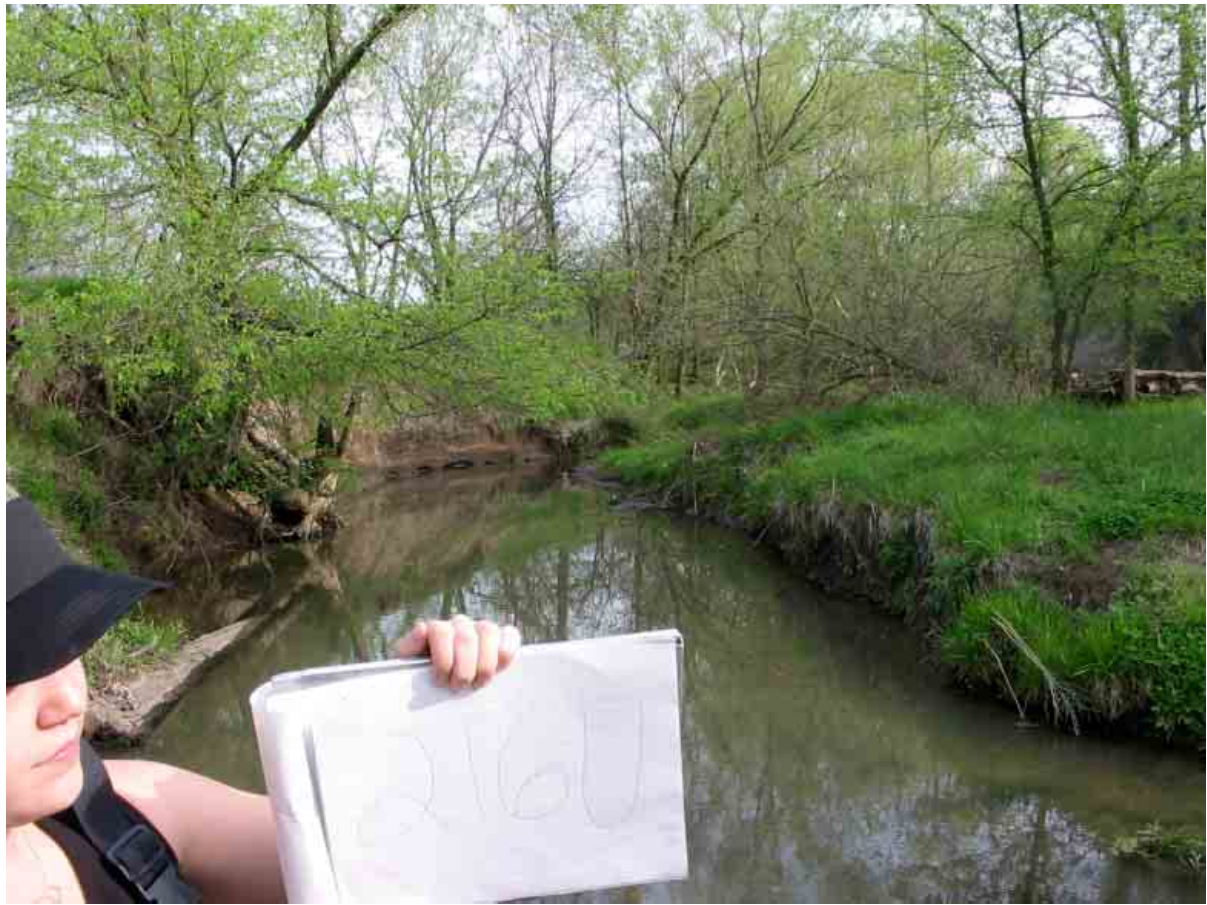
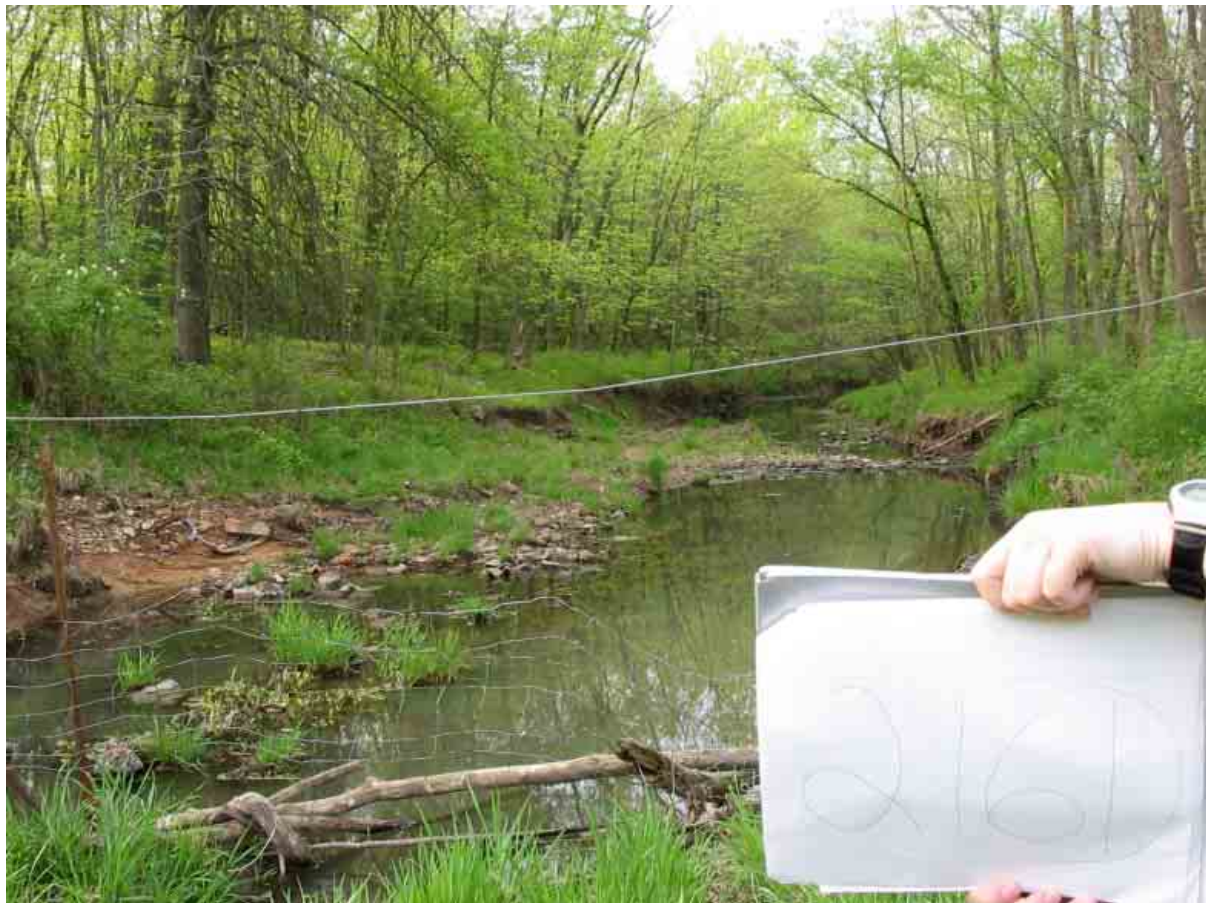
Missouri WBID #: <u>216 Revisit</u>	Site Location Description:	
Site GPS Coordinates: <u>N38.54390 W093.60224</u>	<u>Rt 2 overpass</u>	
Date & Time: <u>4-21-2005 8:55 AM</u>	Facility Name: <u>Middle Fk Tebo CR</u>	
Personnel: <u>CB, ELY</u>	Permit Number:	
Current Weather Conditions: <u>Partly Cloudy 68°</u>	Weather Conditions for Past 7 days:	
Photo Ids: Upstream: <u>1754A 630</u>	Downstream: <u>1753A 629</u>	Other:

- Murky water somewhat clearer in riffle area

- some trash in creek but no signs of human recreational use
